**UNITED STATES AIR FORCE**  
**AIRCRAFT ACCIDENT INVESTIGATION**  
**BOARD REPORT**

**HH-60G, TAIL NUMBER 88-26109**  
**56TH RESCUE SQUADRON**  
**48TH FIGHTER WING**  
**ROYAL AIR FORCE LAKENHEATH**

**LOCATION: CLEY NEXT THE SEA, NORFOLK,  
UNITED KINGDOM**

**DATE OF ACCIDENT: 7 JANUARY 2014**

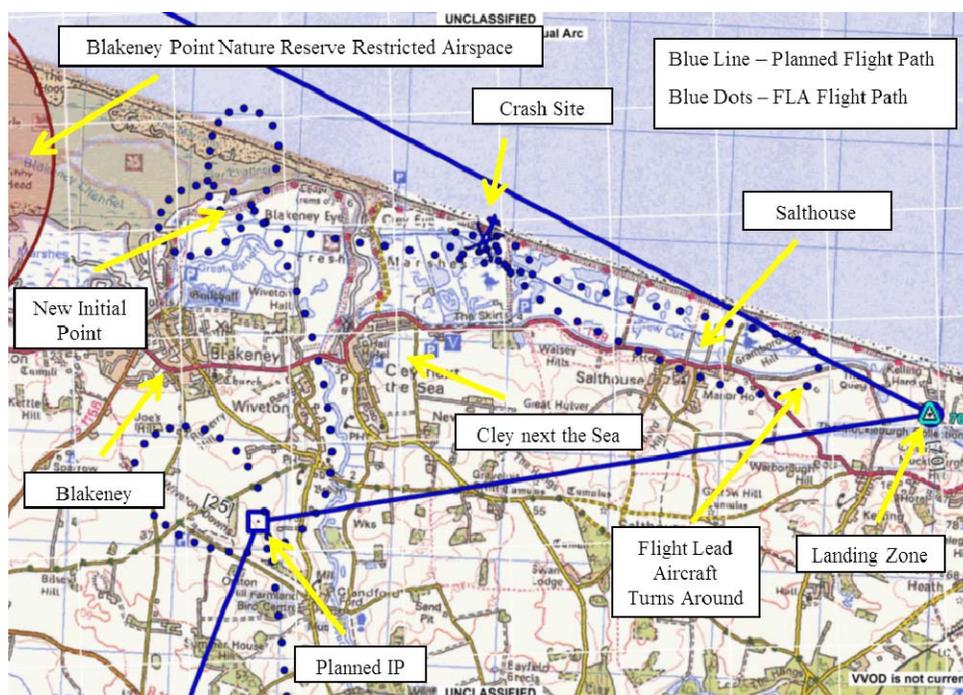
Figure 2: Flight Path of the Flight Lead Aircraft (Tab S-16).

The January 2014 UK bird map depicted a low bird hazard for the route between the new IP and LZ near Salthouse (Tab NN-5). The route from the new IP to the LZ crossed over an area known as Cley Marshes in the Wildlife Trust (see Figure 2 above) (Tab S-16).

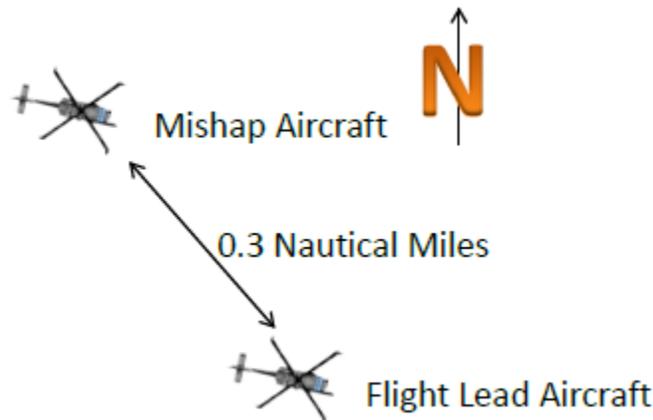
**Figure 3: Relative Position of the Mishap Formation after Departure from the Initial Point (Tab V-3.11).**

At some point during the MF's approach to the LZ, a flock of geese took flight from Cley Marshes. The sound of the approaching MF likely startled the geese (Tab V-13.2 to V-13.3). The geese took approximately one minute to reach 110 feet AGL—the altitude of the MA (Tabs V-13.3 and EE-6 to EE-7).

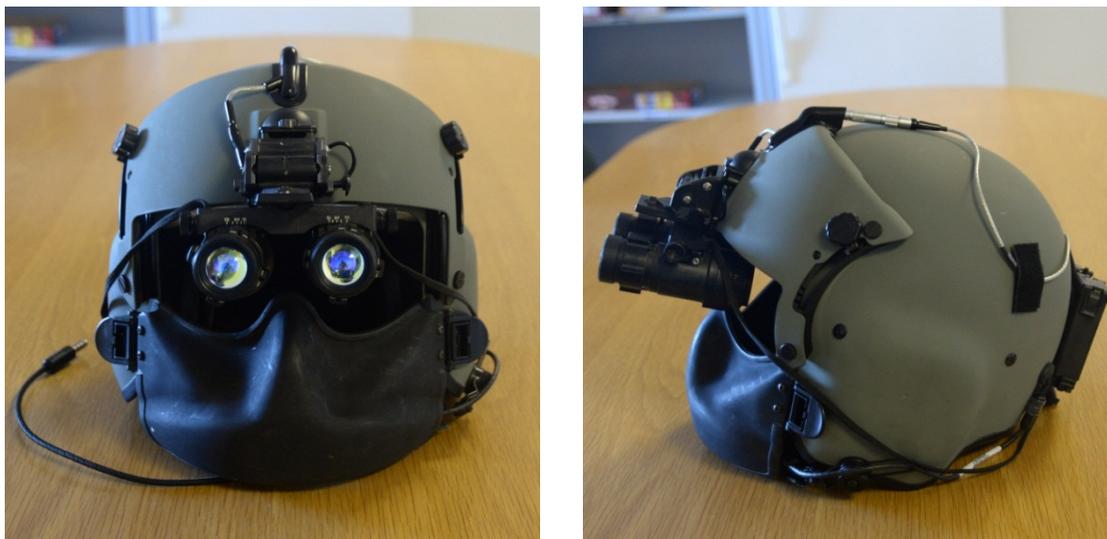
**Figure 4: ANVIS-4949 Night Vision Goggles Mounted to HGU-56/P Helmet (Front and Side Views) (BB-292).**

All four of the MC's NVGs were destroyed in the mishap (Tabs R-131, R-140 to R-141, V-1.17, V-1.21, V-4.15, V-4.18, and V-5.10).

Although the field of view seen through the NVGs worn by the FLC and MC may have limited the ability to sense motion from the geese, I did not find sufficient evidence to conclude the NVGs caused or substantially contributed to the mishap.

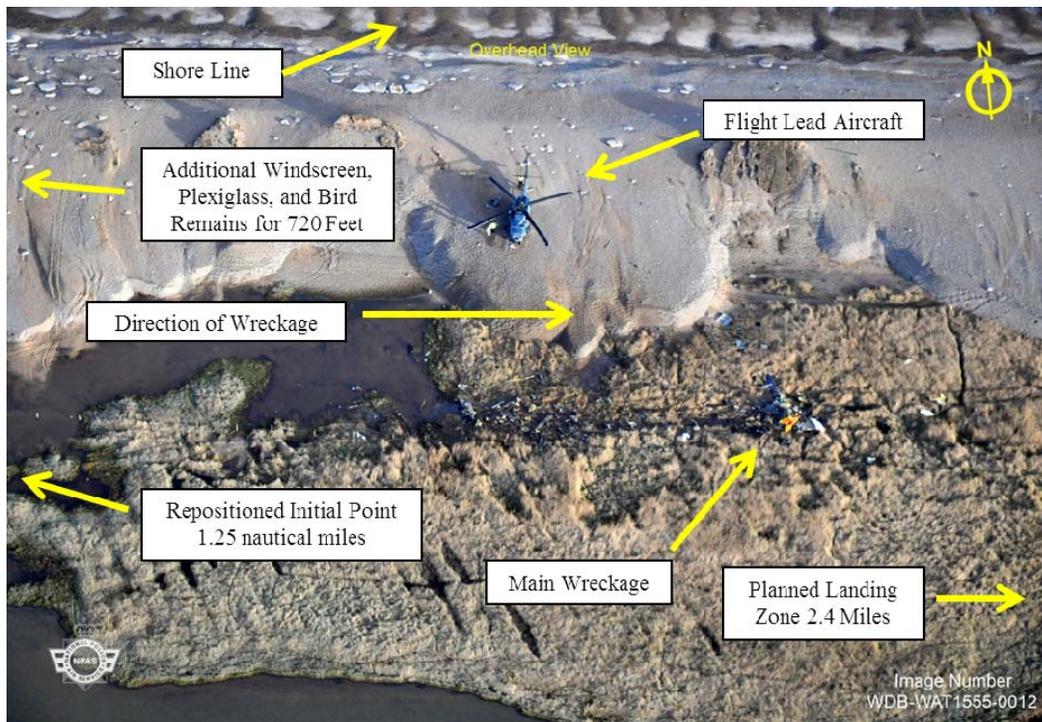
**Figure 5: Crash Site (Tab S-12).**

The majority of the main rotor blades were recovered from the initial impact area (Tab J-10). A series of varying depth blade scars were noted in the mud, just south of the open water, at the start of the primary impact trail (Tab J-10). The direction of the impacts and soil motion are consistent with the aircraft rolled more than 90 degrees to the left (Tab J-10). The tail rotor system was destroyed by ground impact (Tab J-12). The main and tail rotor heads were examined to evaluate functionality prior to the mishap (Tab J-13). The main rotor head sustained damage consistent with blade impacts while being driven at moderate to high power level and full rotational rotations per minute (RPM) (Tab J-13). There was no evidence to suggest any preexisting anomalies on either the main or tail rotor systems were factors in the mishap (Tab J-14).

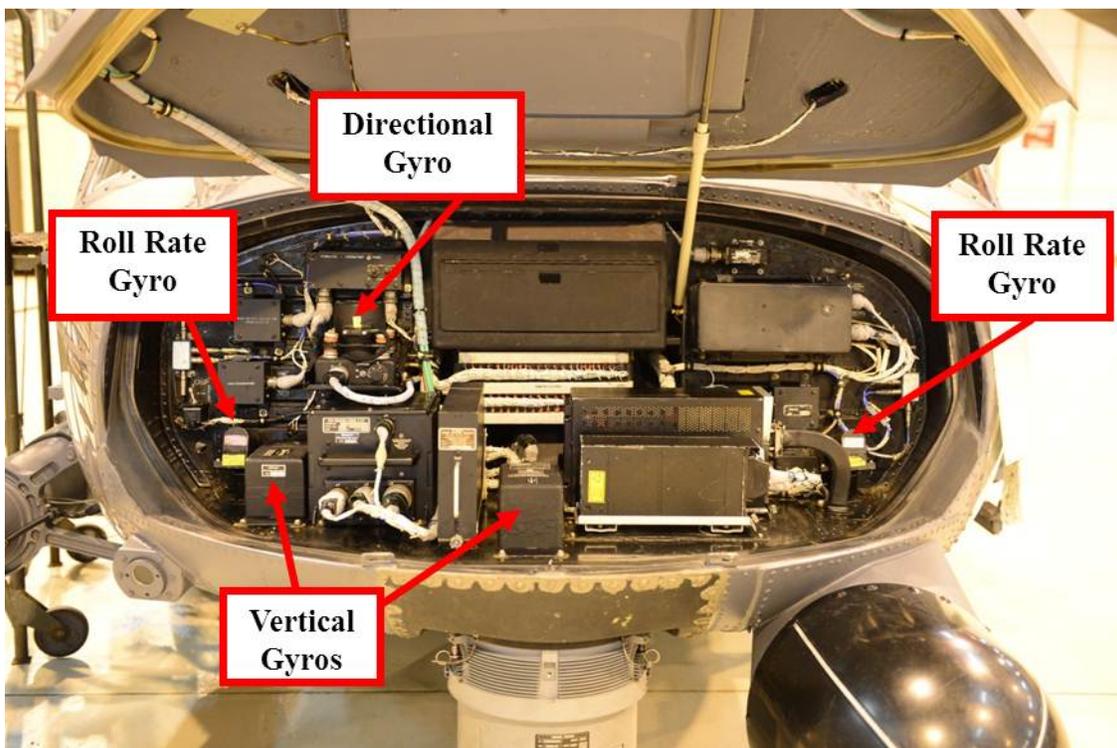
Figure 8: Nose Compartment Avionics (Tab FF-14).

At least one goose struck the nose of the MA, disabling the Trim and Flight Path Stabilization (FPS) systems—two key components of the Automatic Flight Control System (AFCS) (Tab EE-7). The AFCS helps improve aircraft performance by assisting the pilot with aircraft control. It has five subsystems. The Trim and FPS systems provide control positioning and force gradient functions, as well as basic autopilot functions when the FPS is engaged. The force gradient functions cause increasing resistance on the cyclic stick (which controls aircraft pitch and roll) the further the cyclic stick is moved from center (Tab BB-222). Because the impact from the geese rendered MP and MCP unconscious and disabled the Trim and FPS, the cyclic stick was free to move randomly (Tabs V-17.12 to V-17.13 and BB-220). The free-floating cyclic stick fell to the left, inducing a rapid left roll (Tab V-17.17 and V-17.18). Once the MA passed 50 degrees angle of bank, the MA began a descent and continued rolling (Tab BB-133). Simulator testing also showed that the MA could not recover once it passed 50 degrees at 110 feet AGL (Tab EE-9 and EE-10). The MA continued to roll and descend (Tab EE-7).

A certified Air Force Developmental Test Pilot (AFDTP) conducted a thorough ground test of the AFCS and focused particularly on the Trim and FPS systems. The tests verified the impact force from a bird strike to the front of the HH-60G could damage critical components, resulting in the Trim and FPS systems being disabled and taken offline.
