**UNITED STATES AIR FORCE**  
**AIRCRAFT ACCIDENT INVESTIGATION**  
**BOARD REPORT**

**F-15D, T/N 86-0182**

**493D FIGHTER SQUADRON  
48TH FIGHTER WING  
RAF LAKENHEATH, UNITED KINGDOM**

**DATE OF ACCIDENT: 8 OCTOBER 2014**

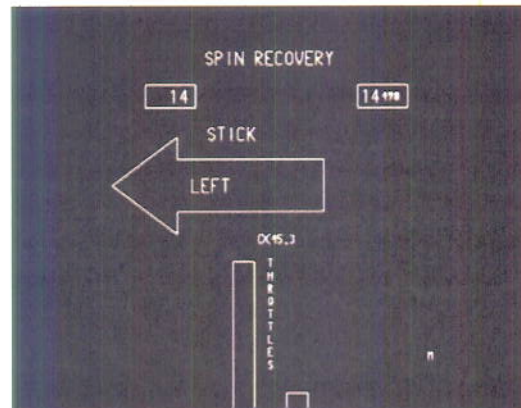
Figure 1: F-15 MPCD Spin Recovery Display (Tab HH-1)

After the MP's abrupt aft-stick pull, the MA's nose made an uncommanded slice to the left (Tab J-18, GG-1.1, HH-1). The SRD initiated 1.6 seconds later when the yaw rate exceeded 60° per second (Tab J-18, HH-1). The SRD activates when the F-15 central computer detects a spin condition (See Figure 1; Tab BB-2.2).

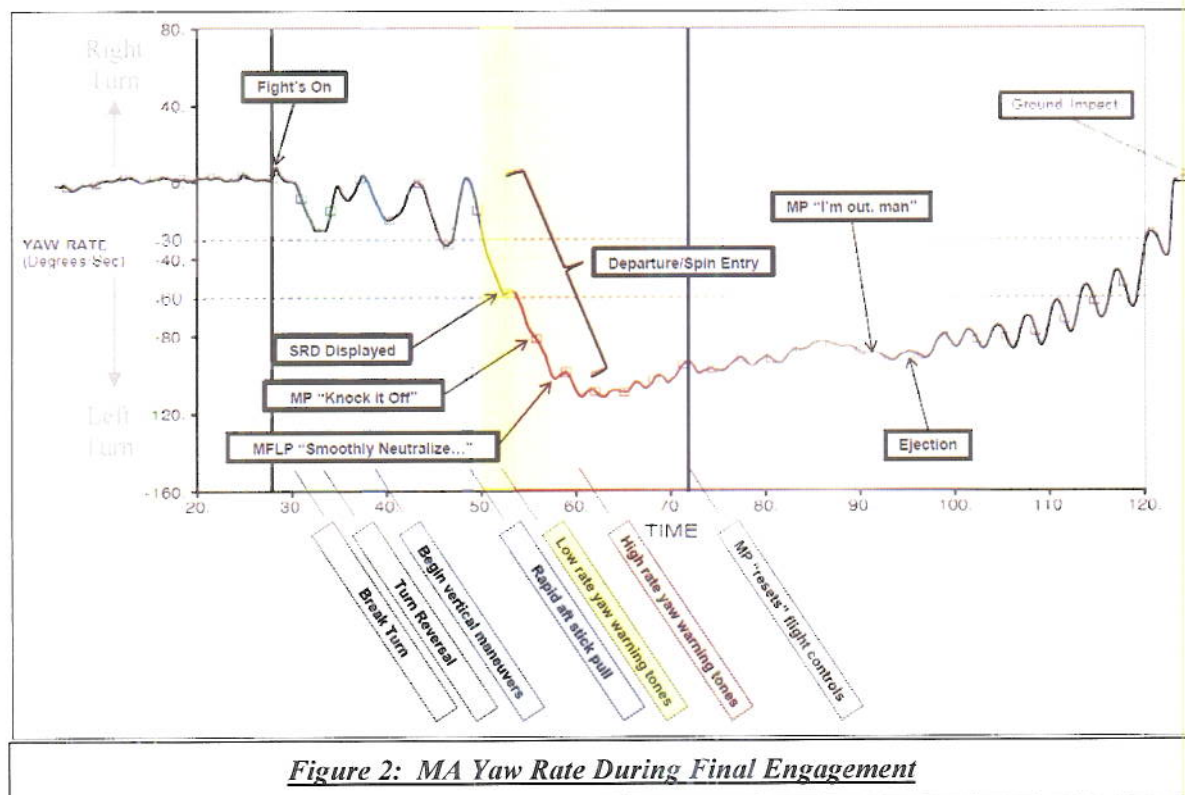
Ten seconds after the initial nose slice and passing 12,200 feet MSL, the MA's yaw rate peaked at 111° per second (See Figure 2; Tab J-18, GG-1.2). At this point, the MA was established in a flat erect spin, as defined in the F-15 Flight Manual (See Figure 2 on the next page for a depiction of yaw rate throughout the mishap sequence; Tab V-1.6, BB-2.16). Even with full

anti-spin flight controls, the MA spin rate slowed at only  $1^\circ$  per second<sup>2</sup> (Tab J-24). At this rate of recovery, it would take between 10,000 and 15,000 feet for the MA to recover (Tab J-27).

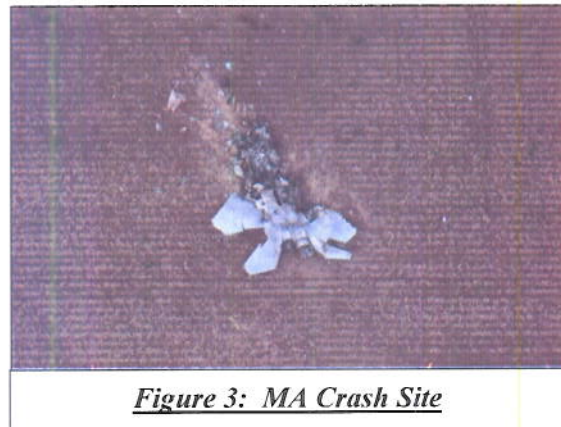
***Figure 3: MA Crash Site***

The MA impacted the ground in a field at 15:28:38L at N52-45.4 E000-06.9, approximately three miles southeast of Spalding, Lincolnshire, UK (See Figure 3; Tab S-12, GG-2). The landing gear, flaps, and speedbrake were all retracted at impact (Tab J-5, J-10, J-13). MA parameters at impact were 105 KCAS, 50° nose-low, in 45° left bank, and on a northwest heading (Tab HH-1). There were no civilian injuries or fatalities (Tab FF-5). Private property damage included fire and impact damage to a local farmer's field (Tab P-2, FF-5).

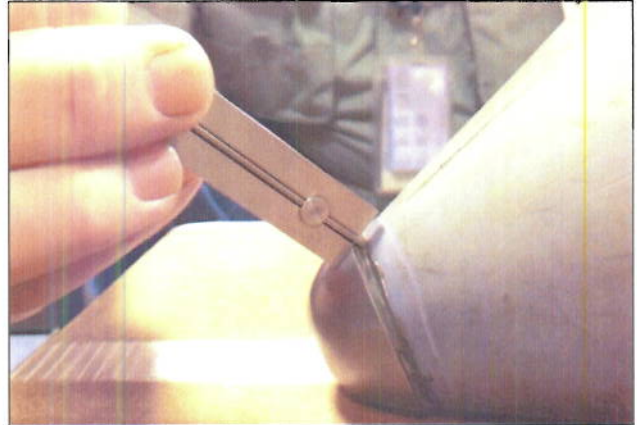
*Figure 4: MA Radome*

**Nose Cap Condition:** Mishap investigators discovered the first 8-10 inches of the aircraft radome in usable condition for analysis (Tab J-20). Figure 4 shows a close up of the tip of the MA's radome, which is protected by a metallic covering called a nose cap. F-15 SPO post-crash analysis assessed that there was a large gap between the radome body and nose cap, and that an excessive amount of sealant extruded from behind the nose cap (See Figure 4; Tab J-20, J-51). The sealant extruded up to 3/16 of an inch aft of the nose cap and created an uneven aerodynamic surface.

According to the F-15 SPO: "A radome in this condition...is consistent with wind tunnel test data that would predict sufficient yaw to depart an aircraft and generate a high enough yaw rate to trigger the [SRD] as well as cause delayed spin recovery..." (Tab J-20). As discussed on page 6 of this report, the AFTTP 3-3.F-15 addresses this phenomenon, as does the F-15 Flight Manual. The Flight Manual states that the AOA levels at which radome imperfections can play a role (50-60 CPU) can be attained "momentarily during abrupt aft stick pulls at approximately 160-275 KCAS..." (Tab BB-2.15, BB-6.4). The Flight Manual goes on to state that if an aircraft experiences a nose-slice while at very high AOA, and other causal factors have been eliminated (lateral asymmetry, improper control inputs, etc.), then the radome may be suspect (Tab BB-2.15).

Analysis of the first 8-10 inches of MA radome, discovered intact at the crash site, revealed there was a large gap between the radome body and the nose cap. At an undetermined time prior to the mishap, the nose plug of the radome became displaced from the radome's composite shell by 3/32 of an inch. The last recorded radome maintenance was accomplished on 22 January 2014, at which time the maintenance technician likely installed the nose cap over the radome and nose plug in this condition. As a result, a larger than normal amount of sealant was required to properly seal the nose cap in place. Some of this sealant extruded from underneath the nose cap, was insufficiently cleaned from the radome surface, and created an uneven aerodynamic surface.

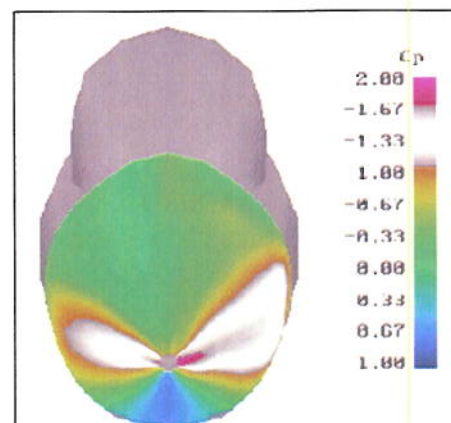
*Figure 5: Pressure differential due to asymmetric vortex shedding*

The yaw forces generated by radome imperfections are due to "asymmetric vortex shedding" (Tab J-19). Figure 5, adapted from a 2000 Atmospheric Flight Mechanics Conference paper, shows the asymmetric pressure differential experienced in these conditions ( $C_p$  stands for coefficient of pressure). The white area depicts negative pressure, or suction, naturally present due to airflows that start at the radome tip and radiate along the fuselage. (Tab JJ-1.5, JJ-1.11). When these airflows separate from the nose, a region of positive pressure develops (depicted by the reduced region of white on the left side of the picture). This zone, starting at the tip of the radome, can extend up to 11 feet along the side of the aircraft fuselage. This "zone of pressure differential" not only spreads along the side of the fuselage, but also acts like a 27-foot long lever from the aircraft's center of gravity (also referred to as a moment arm). As a result, this pressure differential can create extreme yaw forces

(Tab BB-6.4). While asymmetric vortex shedding will always happen at extreme AOA levels, radome imperfections lower the AOA at which this can occur to as low as 50 CPU (Tab BB-6.4).

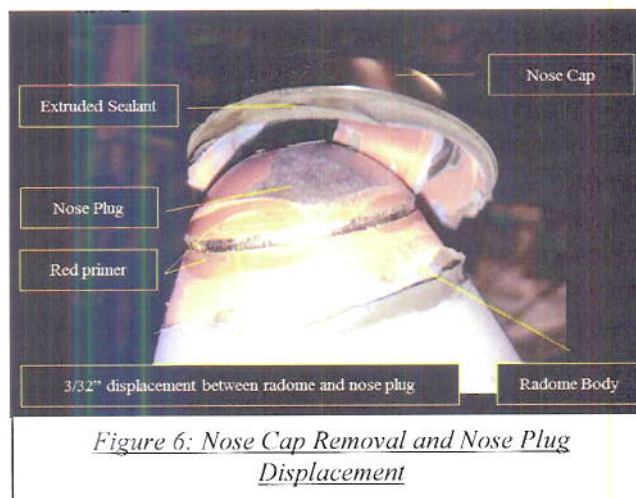
*Figure 6: Nose Cap Removal and Nose Plug Displacement*

an unknown time, during nose cap removal, "the application of heat and/or blunt force necessary to remove the [nose cap] also caused the [nose plug] to pull...away from the [radome body]" (Tab J-55). This nose plug displacement can be seen in Figure 6 where there is silver metal showing between the red primer painted on both the radome body and nose plug. Normally, a nose cap should fit snugly over the nose plug-radome assembly; however, efforts to install the nose cap over the nose plug/radome assembly with this displacement created a large gap between the nose cap and radome (See Figure 7).

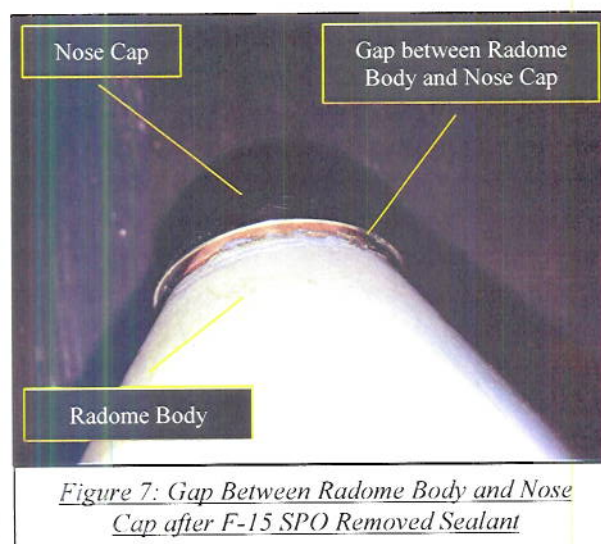
*Figure 7: Gap Between Radome Body and Nose Cap after F-15 SPO Removed Sealant*

The existence of this large gap between the nose cap and radome required a larger than normal amount of sealant in order to completely seal the nose cap in place. Some of this sealant filled in the 3/32 of an inch displacement between the radome and the nose plug (Tab J-55). The sealant that hardened in this space between the radome body and the nose plug is the primary evidence the nose cap was installed while the nose plug was still displaced from the radome (See Figure 8). This sealant formation also serves as evidence that this condition existed prior to the mishap and that the MA's impact with the ground did not somehow displace the nose plug. Otherwise, the

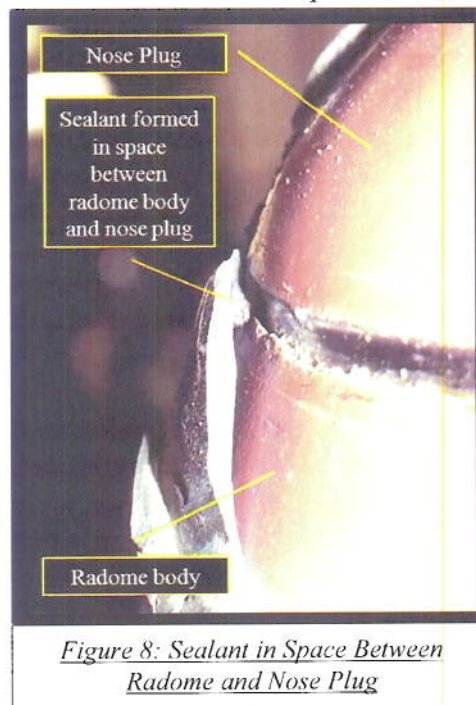
sealant would not appear as it does in Figure 8, where it clearly filled and then hardened in the 3/32 of an inch space between the radome and nose plug.
